DEPARTMENT OF TRANSPORTATION**DIVISION OF ENGINEERING SERVICES**

Contract #: 04-0120F4Cty: SF/ALA Rte: 80 PM: 13.2/13.9File #: 69.28**WELDING INSPECTION REPORT****Resident Engineer:** Pursell, Gary**Address:** 333 Burma Road**City:** Oakland, CA 94607**Report No:** WIR-005639**Date Inspected:** 26-Feb-2009**Project Name:** SAS Superstructure**OSM Arrival Time:** 645**Prime Contractor:** American Bridge/Fluor Enterprises, a JV**OSM Departure Time:** 1845**Contractor:** Zhenhua Port Machinery Company, Ltd (ZPMC), Changxing Island **Location:** Shanghai, China**CWI Name:** Hu Wei Oing**CWI Present:** Yes No**Inspected CWI report:** Yes No N/A**Rod Oven in Use:** Yes No N/A**Electrode to specification:** Yes No N/A**Weld Procedures Followed:** Yes No N/A**Qualified Welders:** Yes No N/A**Verified Joint Fit-up:** Yes No N/A**Approved Drawings:** Yes No N/A**Approved WPS:** Yes No N/A**Delayed / Cancelled:** Yes No N/A**Bridge No:** 34-0006**Component:** OBG**Summary of Items Observed:**

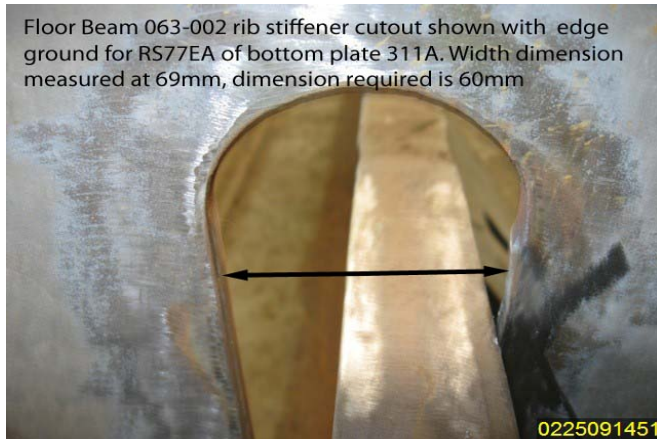
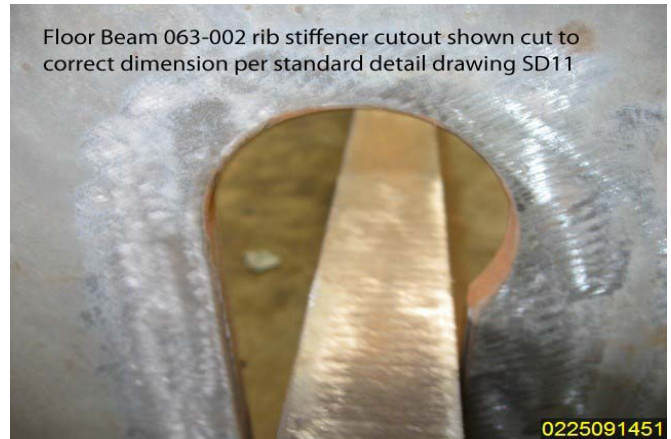
OBG bay 2 Caltrans Quality Assurance (QA) Inspector observed five (5) floor beam cutouts for bottom plate rib stiffener (RS) penetrations had been ground on one side to facilitate fit up of floor beam to bottom plates. The standard drawing SD11 detail 11J lists the floor beam cutout width dimension to be 60mm. Bottom plate 309A

RS77E has a cutout width dimension of 68mm, RS78E cutout width dimension of 66mm. Bottom plate 311A RS77EA cutout width dimension of 69mm, RS87GA cutout width dimension of 65mm, and RS85C cutout width dimension of 65mm due to ZPMC grinding. QA Inspector asked ZPMC QC CWI Nu Wei Oing if ZPMC had written approval to grind and change the dimensions of the floor beam cutouts. QC CWI explained ZPMC had no written approval to make the change. Please see incident report dated 26 February, 2009 for further details. Representative pictures shown below.
